#### eport of Project Nr 2787 - Armalite (AR-15)

#### UNITED STATES ARMY INFANTRY BOARD Fort Benning, Georgia

27 May 1958

#### REPORT OF PROJECT NR 2787 EVALUATION OF SMALL CALIBER HIGH VELOCITY RIFLES - ARMALITE (AR-15) (DA PROJECT 502-08-006) (U)

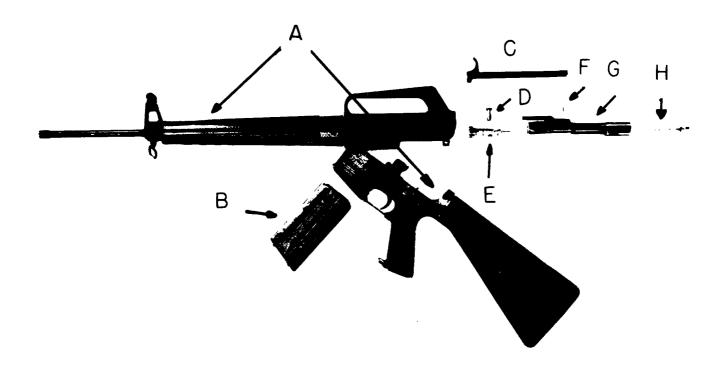
Ang 111-1

Top: Armalite (AR-15), Left Side View. Bottom: Armalite (AR-15), Right Side View.
